**DOT/FAA/AR-96/21**

# **Composite Failure Analysis Handbook Update 1**

**WL-TR-93-4004**

August 1997

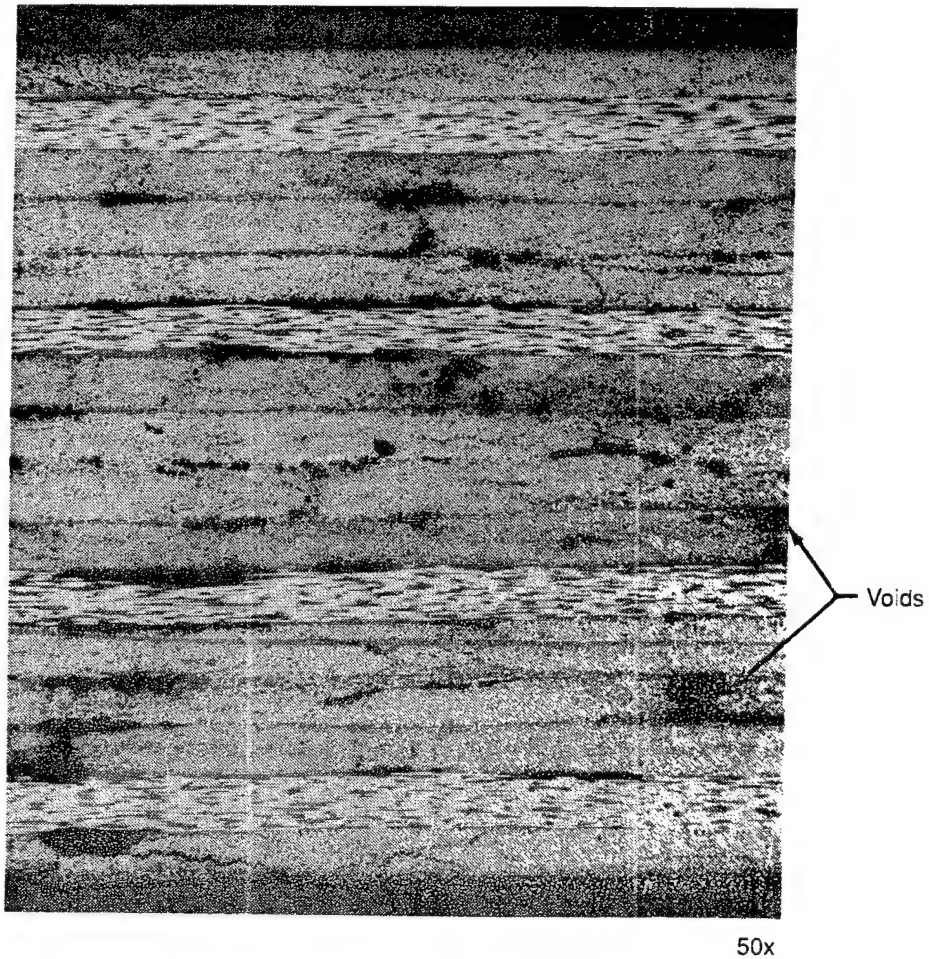
A small section of the panel was cut, mounted, ground and polished. The facesheet ply orientation sequence was: [(+45/90/0/-45)2]s. Major voids were observed throughout the facesheet (see Figure 15). This could be the result of incorrect processing of the composite material prior to assembly of the entire component because the adhesive bond appeared to have been processed correctly.

*Figure 15. Cross-Sectional Micrograph of the CFRP Face Sheets  
Showing the Extent of Porosity and the Lay-Up Sequence*

- d. There was a uniform distribution of voids or porosity throughout the CFRP face sheets.
- e. Damage to the honeycomb core was either deformation or fracturing. In both cases, the damage only occurred in the center of the cell walls and not at the core-adhesive region.

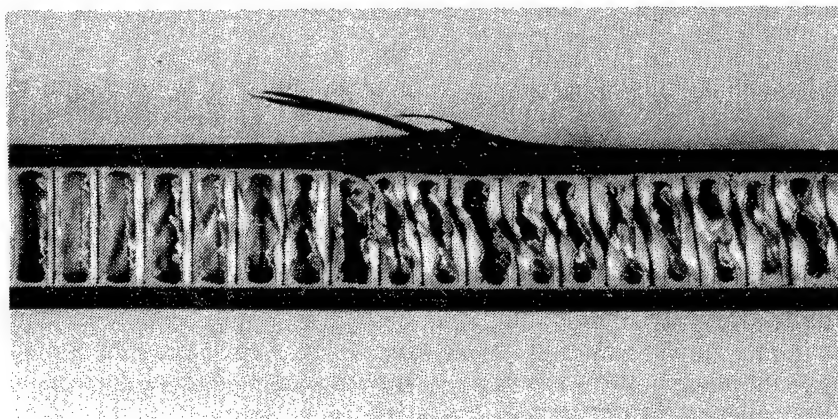
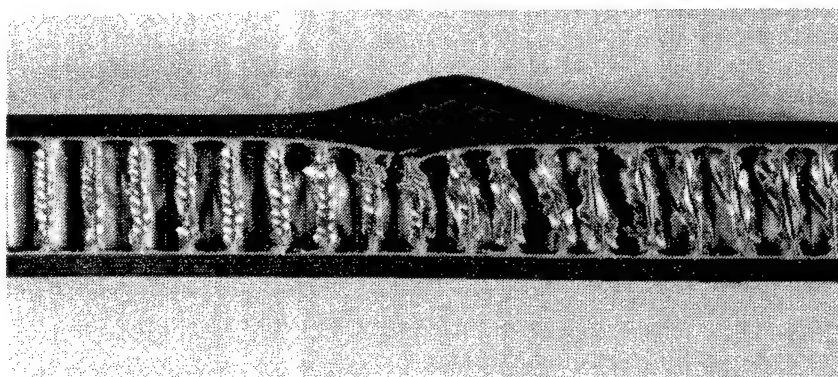
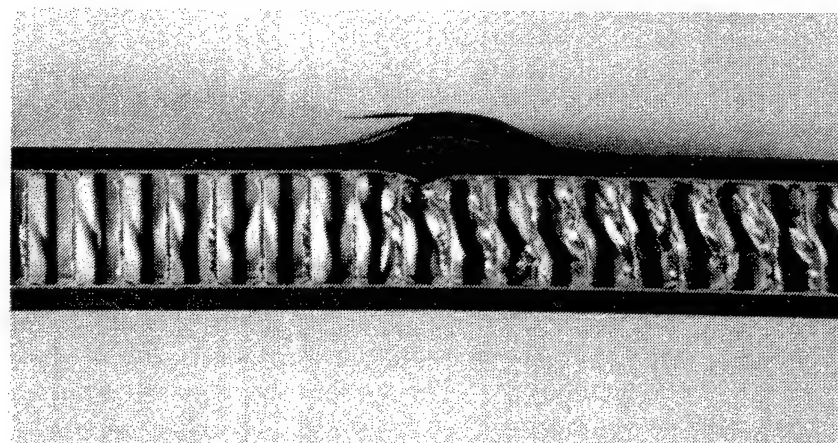
The component was sectioned longitudinally along the same three locations as the CT scan slices to obtain a more detailed examination of the damage within the panel. Figure 16 shows the cross-section at the right edges of each section which correspond to the CT images in Figures 9 to 11. Examination of the surfaces reveal damage similar to the CT images.

Figure 16. Photographs of Cross Sections Through the Panel Corresponding to the CT Scans:

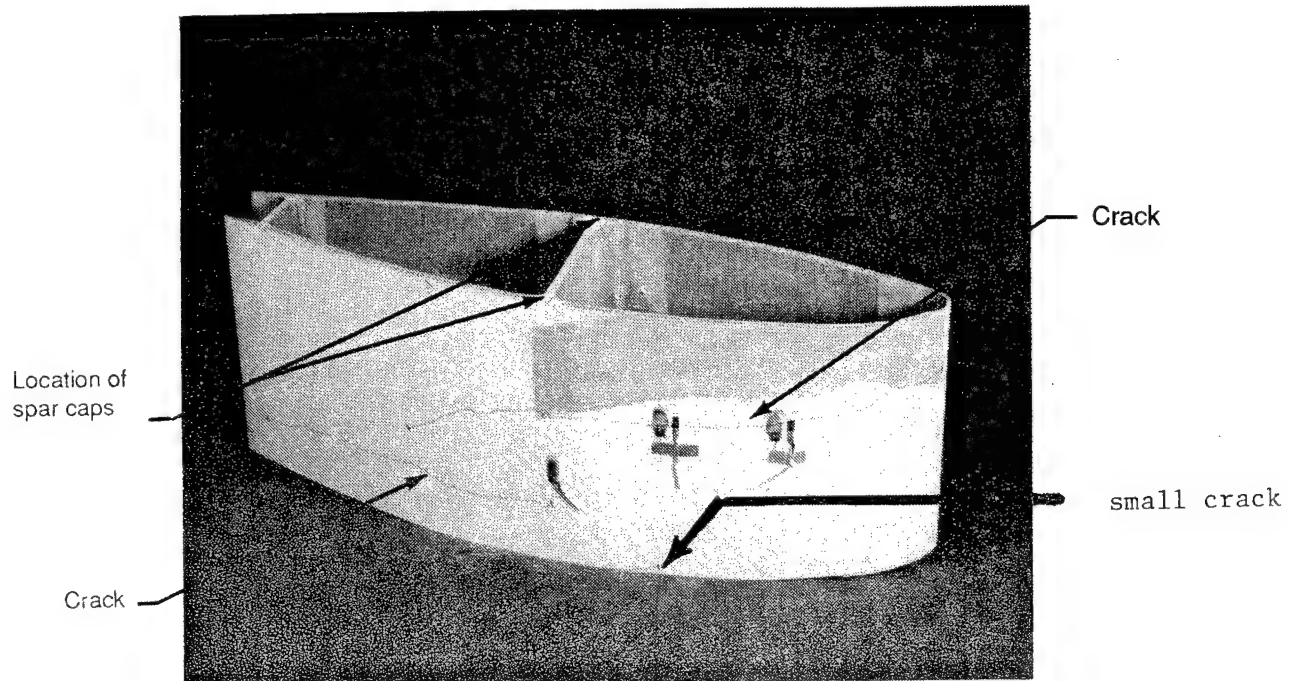
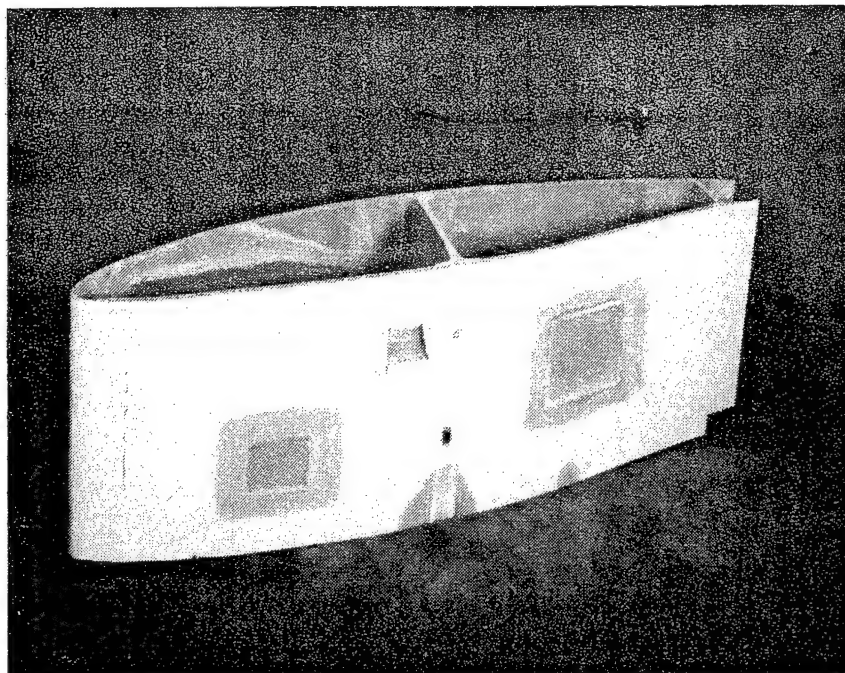
**Outer Wing Surface** - The upper wing skin was composed of a paper honeycomb core with layers of fiberglass plies on both sides. White Gelcoat was present on the outer surfaces. The upper skin contained two long cracks and one small crack. One long crack extended approximately three quarters of the way from the leading edge towards the aft. The other long crack was located between the mid spar and the aft spar. The small crack was located on the edge of the wing section near the middle of the wing section. In addition to the cracks; a large section of the surface, located adjacent to one edge and between the leading edge and the mid spar, had been sanded through the gelcoat.

The lower skin, fabricated identically to the upper skin, contained five regions which appeared to be in various stages of repair. Two of the regions (one ~5.5 and the other ~3.0 inch square) were located in the main section of the lower skin. Both contained exposed honeycomb and white potting compound along the perimeter of the exposed regions. In addition, the surfaces adjacent to these two regions were sanded. Another region (~2.0 inch square) simply had the honeycomb removed down to the inner surface skin. Finally, two sanded regions were located on the edge of the lower skin, one at the spar cap and the other aft of the mid-spar. Both of these regions were approximately 2 inch square and had also been sanded through the Gelcoat.

Figure 2. Photographs of the Outer Surfaces of the Wing Section  
 a) Upper Surface  
 b) Lower Surface
